AGENDA
Cascade Charter Township
Thornapple River SAD Ad-Hoc Committee
Monday, February 12, 2024
5:30 pm
5920 Tahoe Dr. SE

**THORNAPPLE RIVER
SPECIAL
ASSESSMENT
DISTRICT**

**ANNUAL
REPORT**

Thornapple River Safety and Navigation Marking Plan

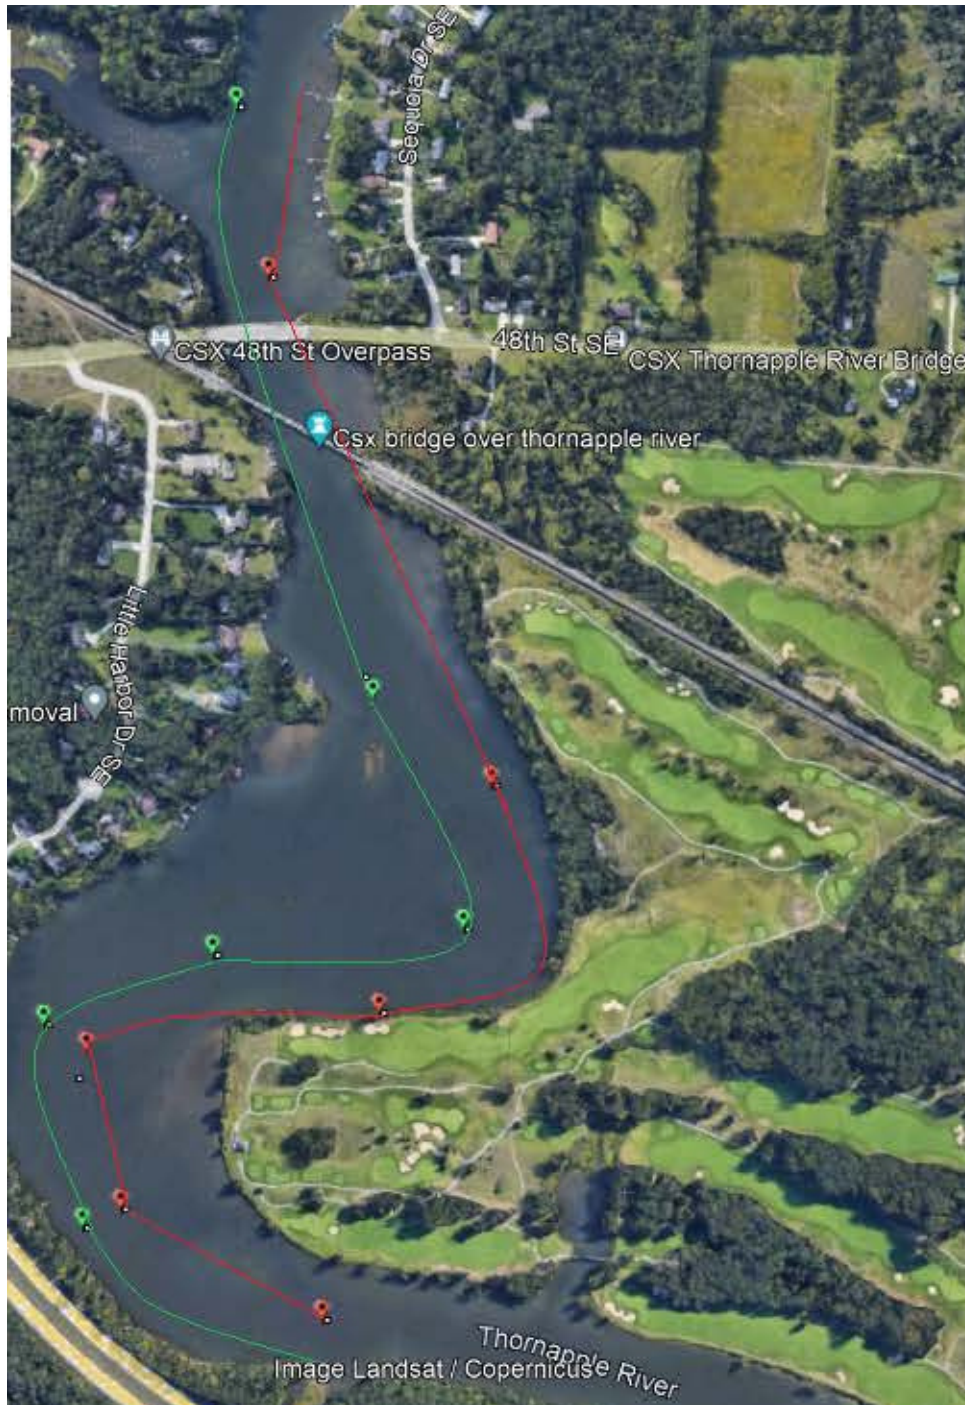
CHANNEL MARKERS

Please Note: The location of the channel markers on this drawing are not to scale. They are located in an appropriate area. Final channel marker placement will be based off of a hydrographic survey and GPS positioning.

Pages 7-8 Channel Markers

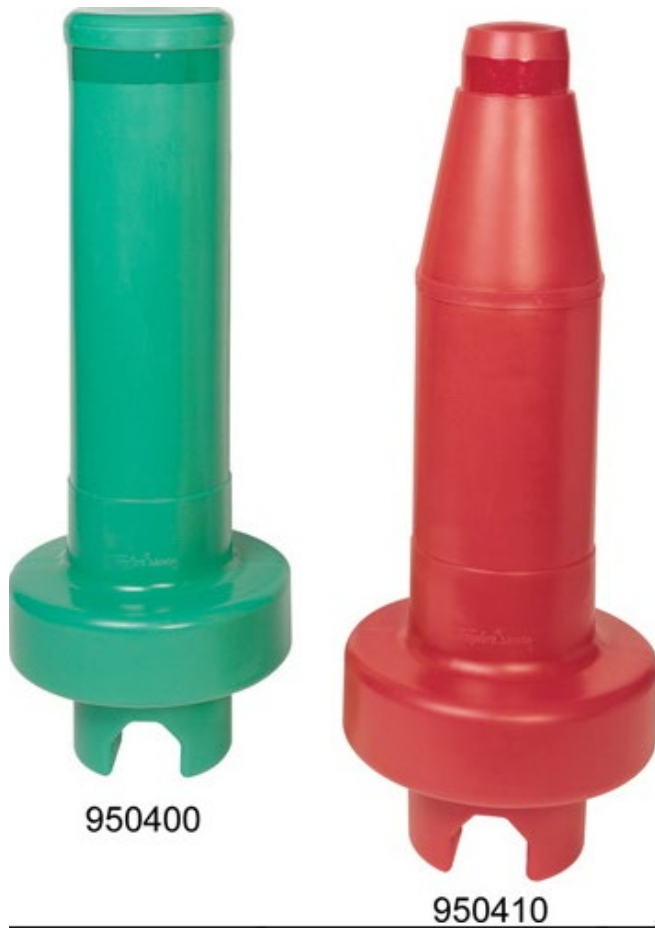
Picture of Green and Red Buoys:

- Taylor Made Sur-Mark, Green and Red:
 - Height: 49"
 - Col. Diameter: 10"
 - Large Ring Diameter: 18"
 - Approx. Buoyancy: 40 lbs
 - Visibility Height Above Waterline: 39"

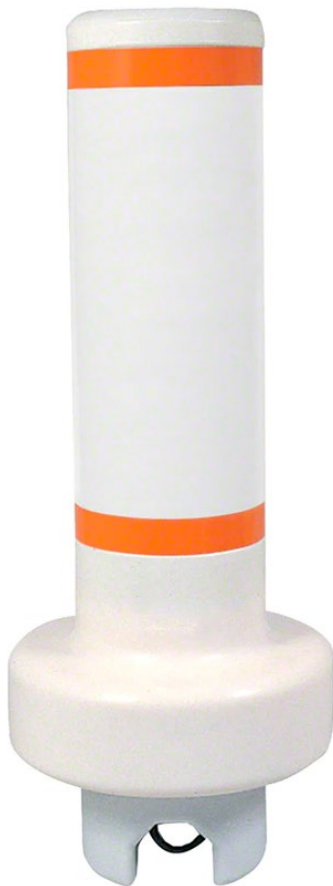
Picture of Orange/White without chosen label:

- Taylor Made Sur-Mark
- Visible 39 inches above waterline
- One-piece seamless construction
- Molded from tough UV protected polyethylene
- Approximate buoyancy: 40 lbs.
- Three-Year Flotation Warranty
- Labels options must be chosen in advance

46171 Shallow Area 46183 Danger
46173 No Boats 46184 Danger Rocks
46175 Keep Out 46185 Swim Area Hazard
46180 Slow 5 MPH 46187 Hazard Area
46181 Slow No Wake 46188 Idle Speed
46182 No Swimming 46191 Danger Keep Out

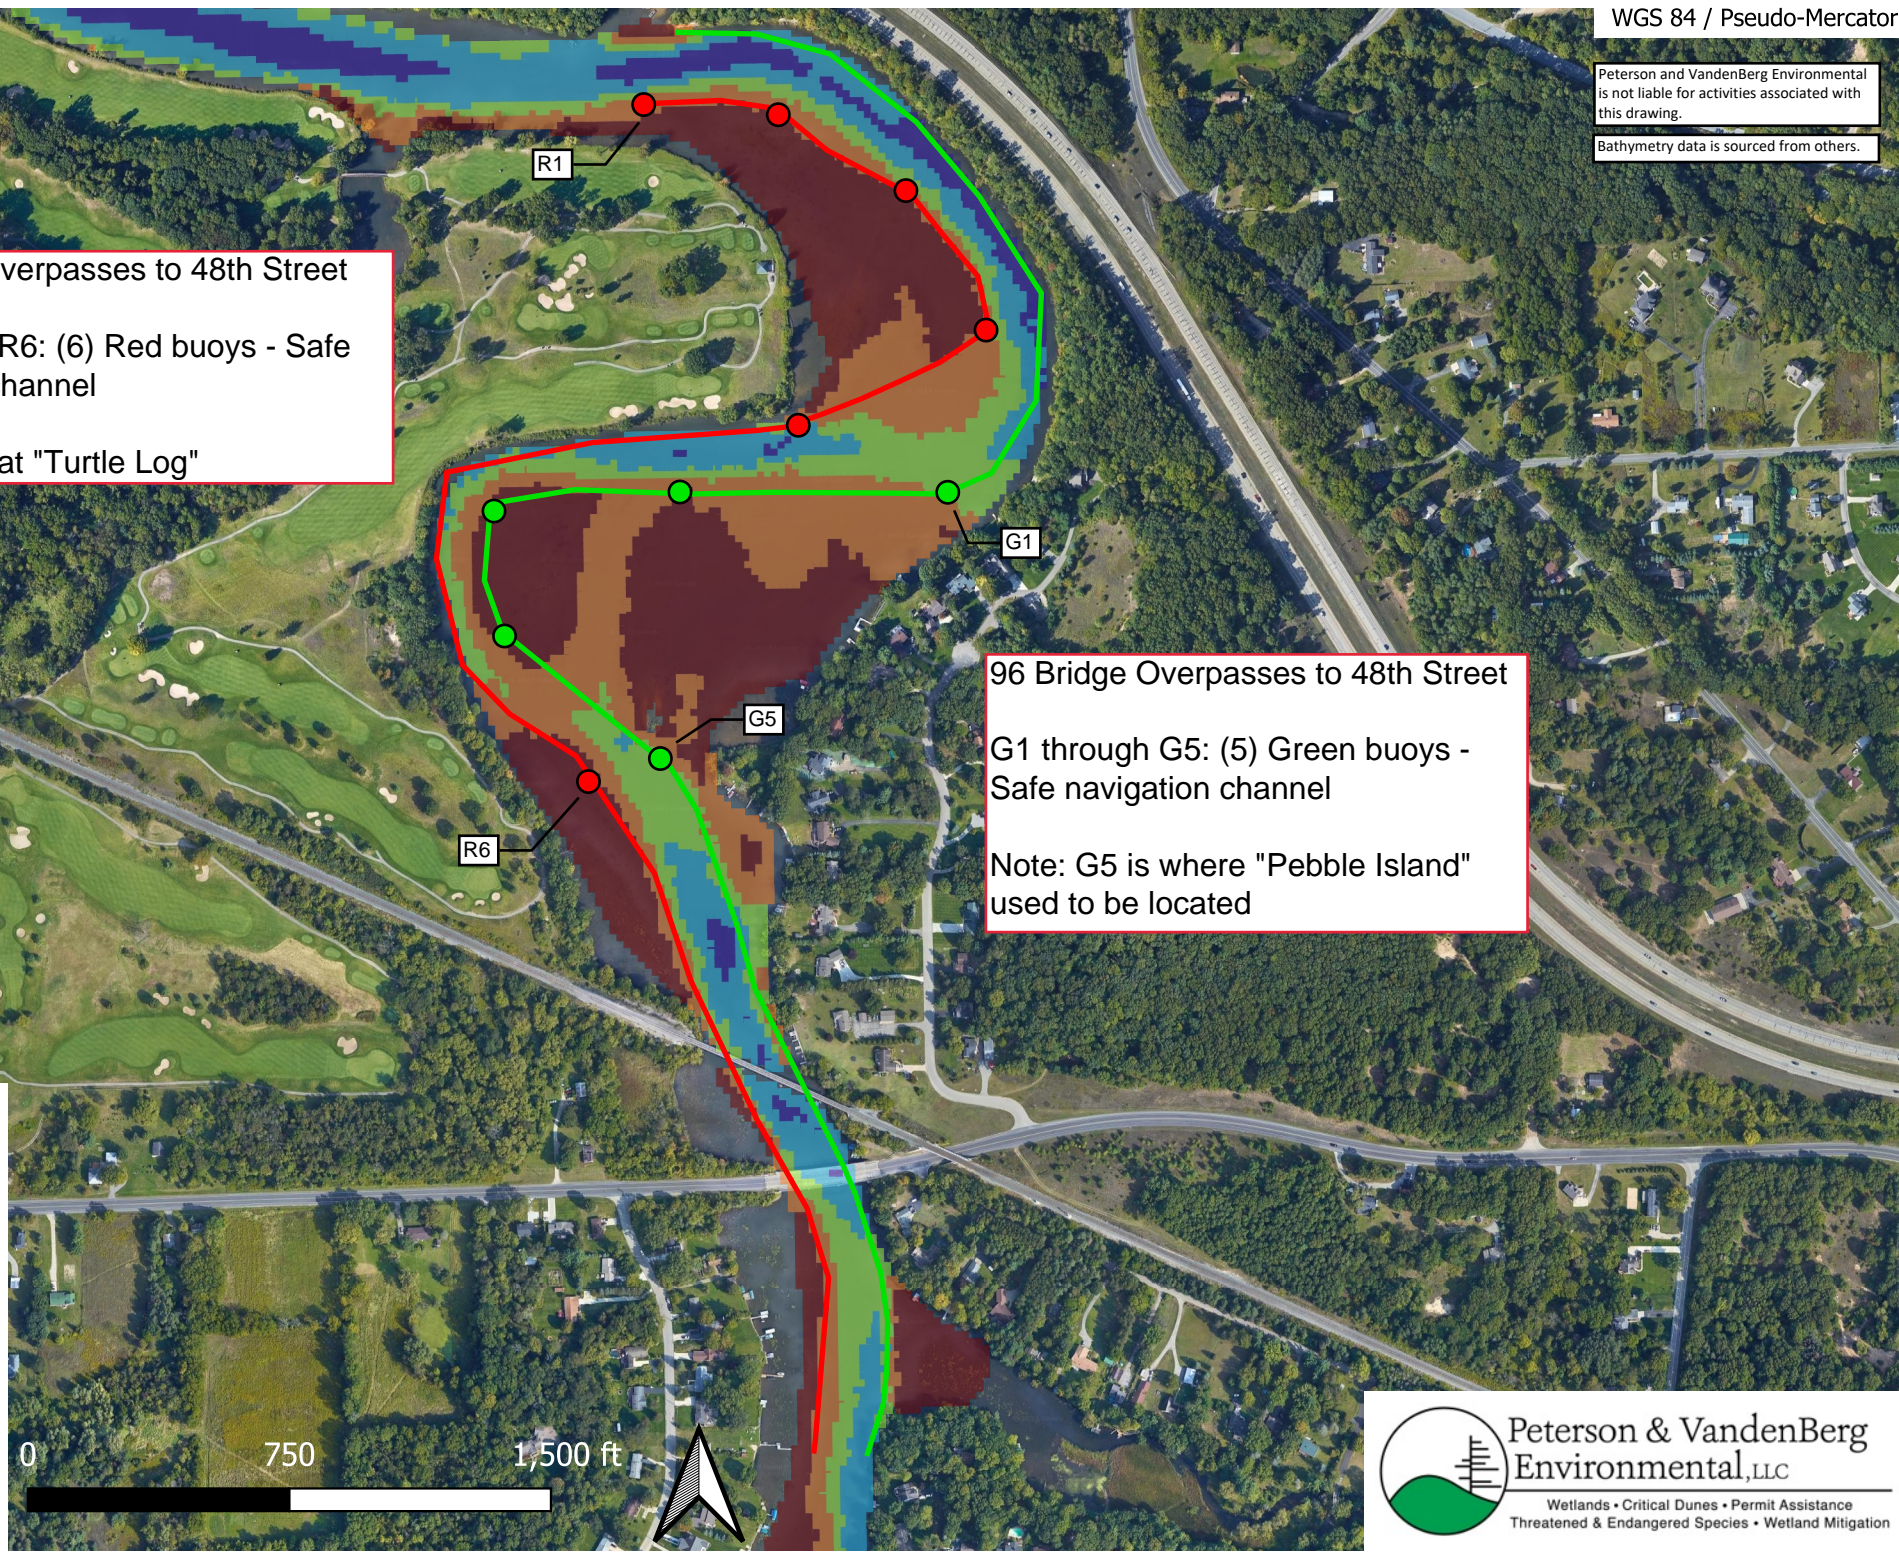
96 Bridge Overpasses to 48th Street
G1 through G5: (5) Green buoys - Safe navigation channel
Note: G5 is where "Pebble Island" used to be located

- Legend**
- Red Buoys
 - Green Buoys
- Surveyed Depths (ft)**
- -22.7 - -13.4
 - -13.4 - -10.3
 - -10.3 - -7.7
 - -7.7 - -5.2
 - -5.2 - -1.6

Bathymetry data is sourced from others.

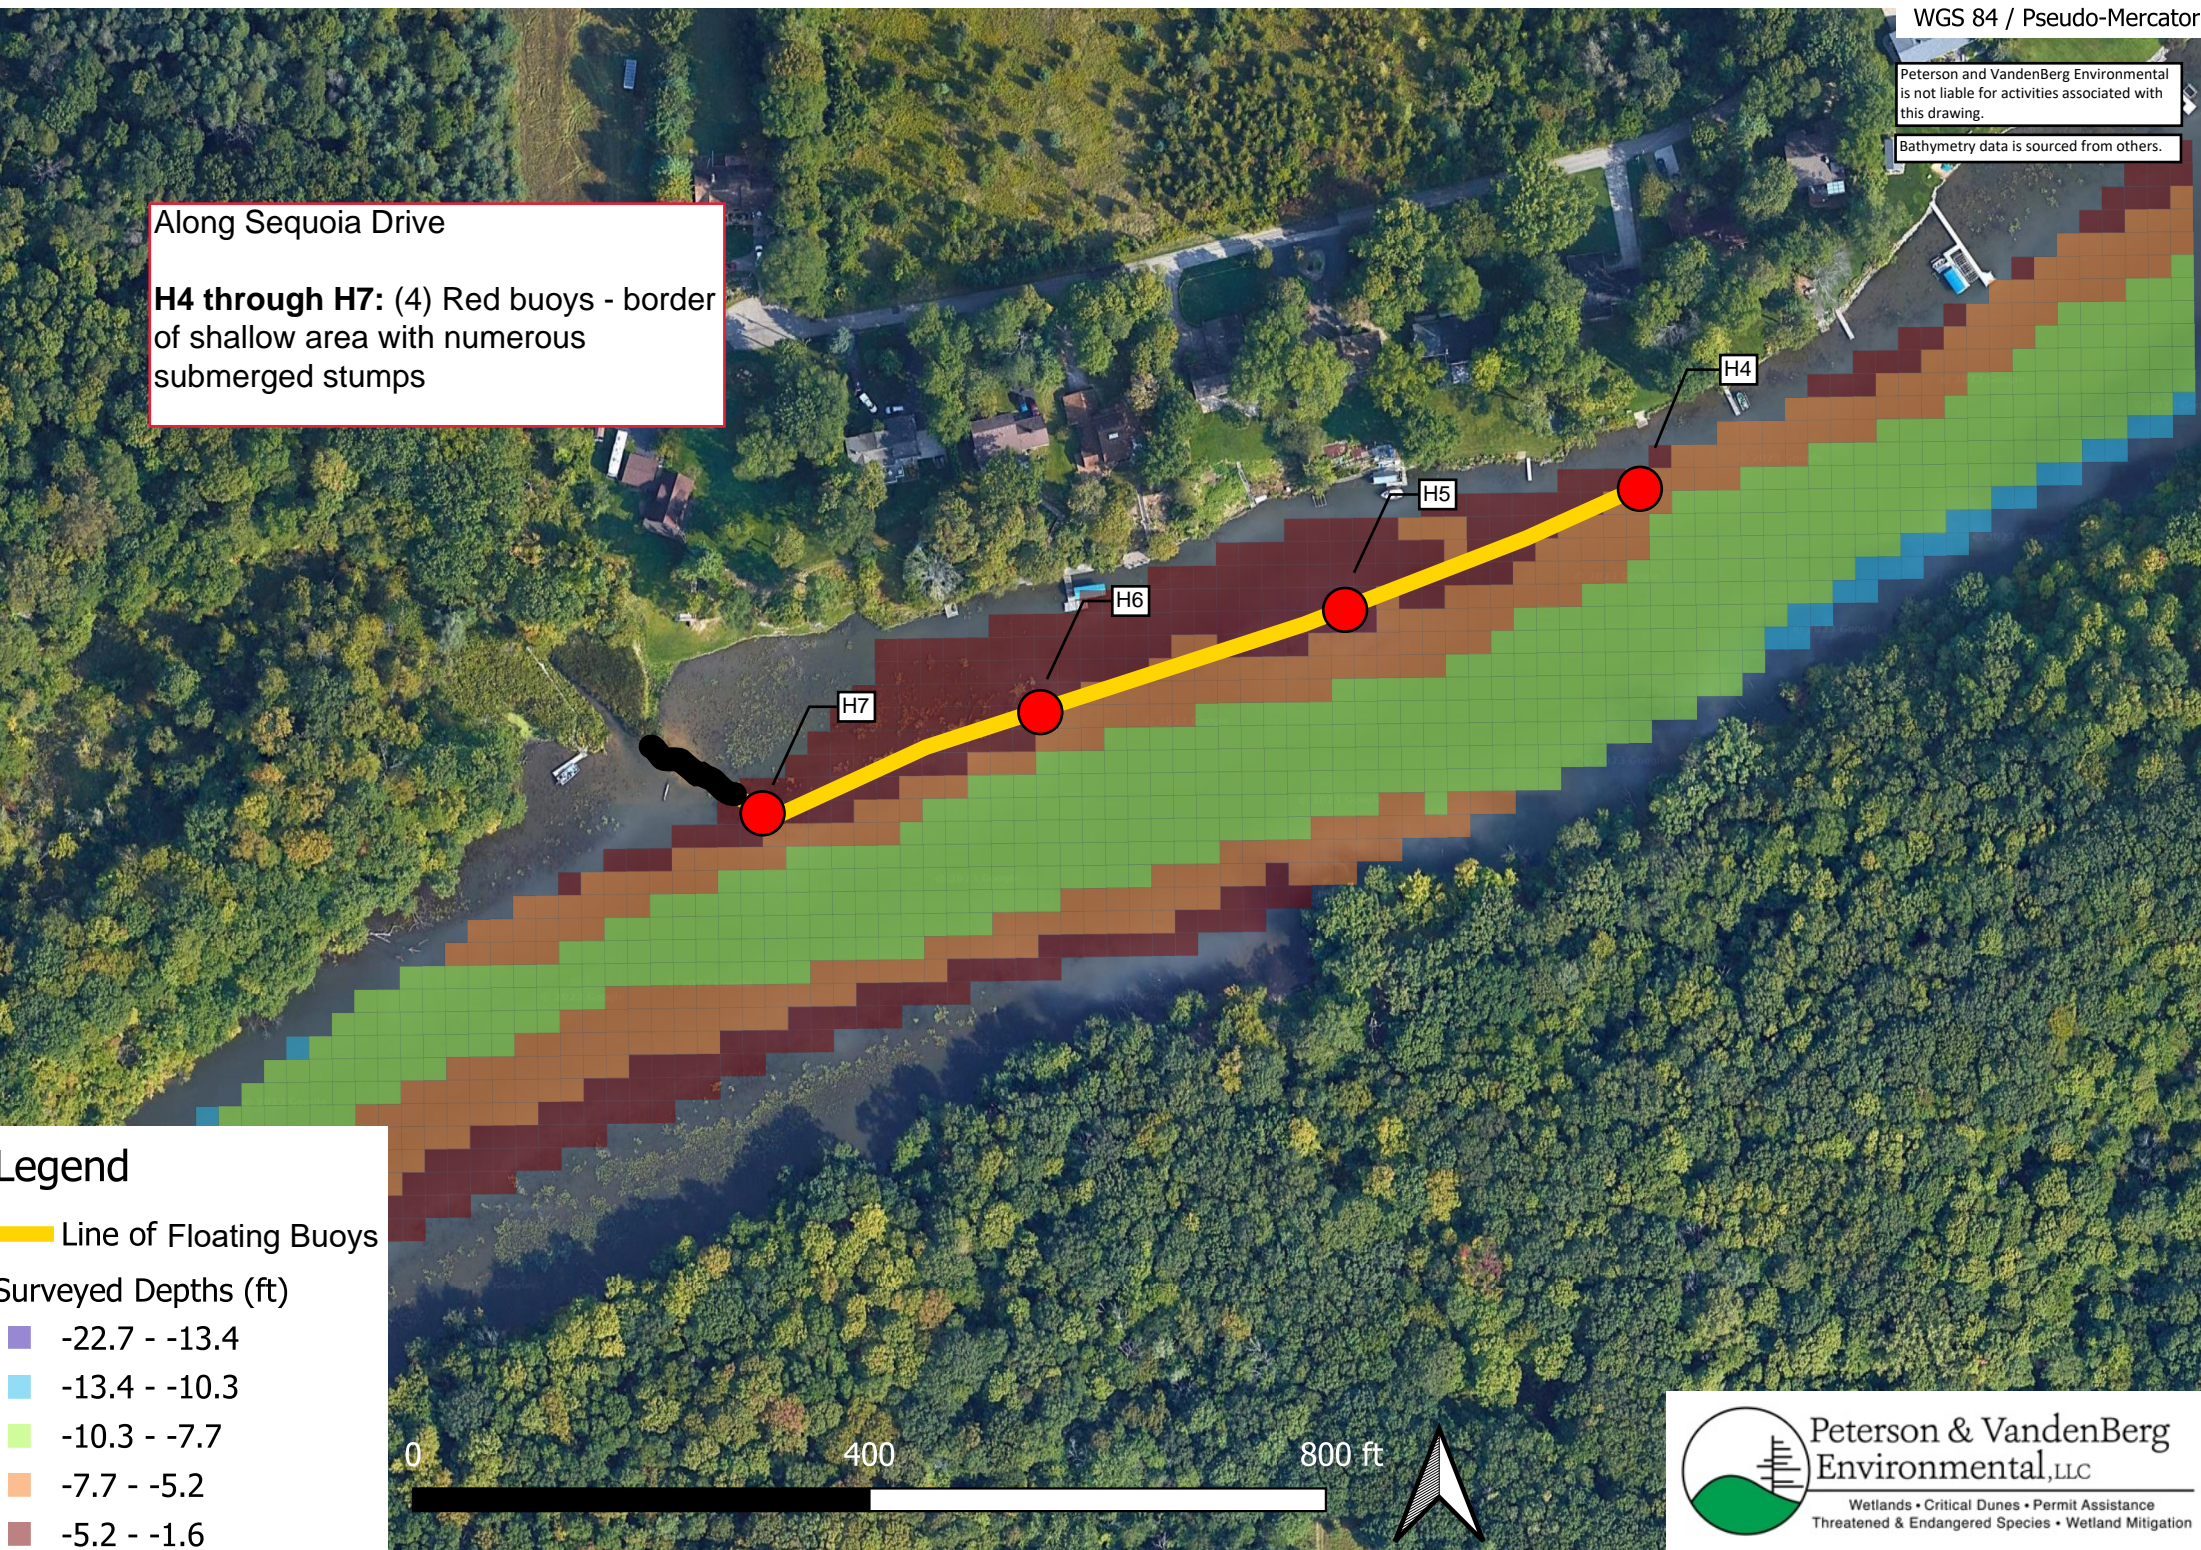
Along Sequoia Drive
H4 through H7: (4) Red buoys - border of shallow area with numerous submerged stumps

Line of Floating Buoys
